# Roland SERVICE INFORMATION

100204

JP-8

TO SERVICE ENGINEERS: SUBJECT  
Hum and Sound leakage

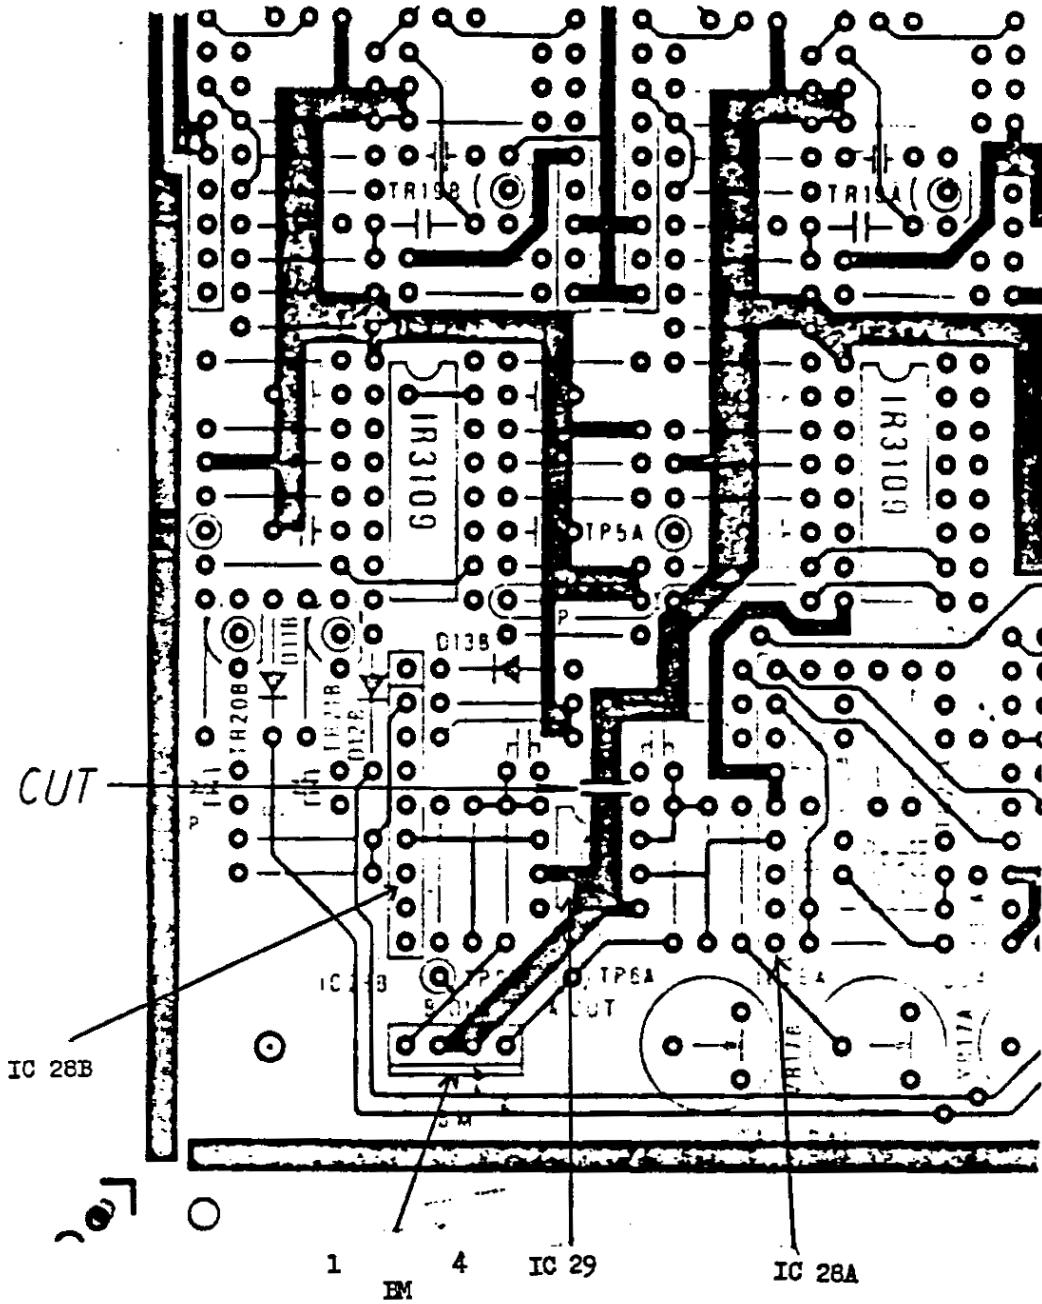
DRAWING No.1

部品面 パターンカット 1ヶ所 COMPONENT SIDE

STEP 1 : Cut off a part of a pattern on the "Component Side" Confer the enclosed drawing No.1.

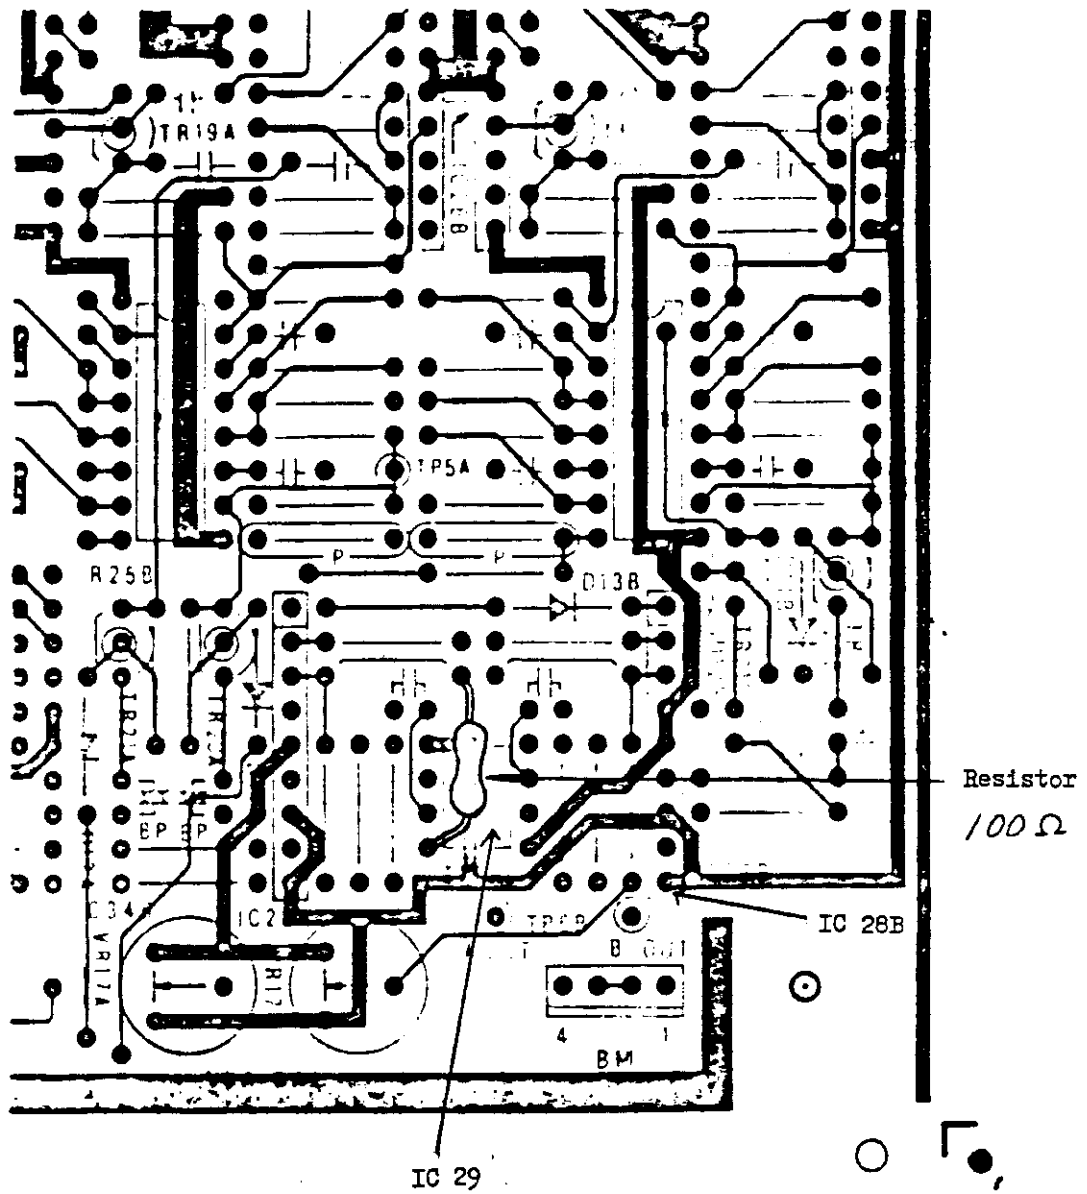
DRAWING No.2

FOIL SIDE

STEP 2 : Add a new resistor 100 ohm to each Module Board at the place where the pattern is cut off (to cut a ground loop) on the "Foil Side". Confer the drawing No.2.

半田面 抵抗100 $\Omega$ 裏付1ヶ所
