<b>ROLAND SERVICE INFORMATION</b>	NO.	100222
	DATE	August 4, 1984

PRODUCT AFFECTED: JUNO-106

TO SERVICE ENGINEERS: SUBJECT  
COUNTERMEASURE TO MEMORY BACK UP BATTERY

JUNO-106 MODIFICATION

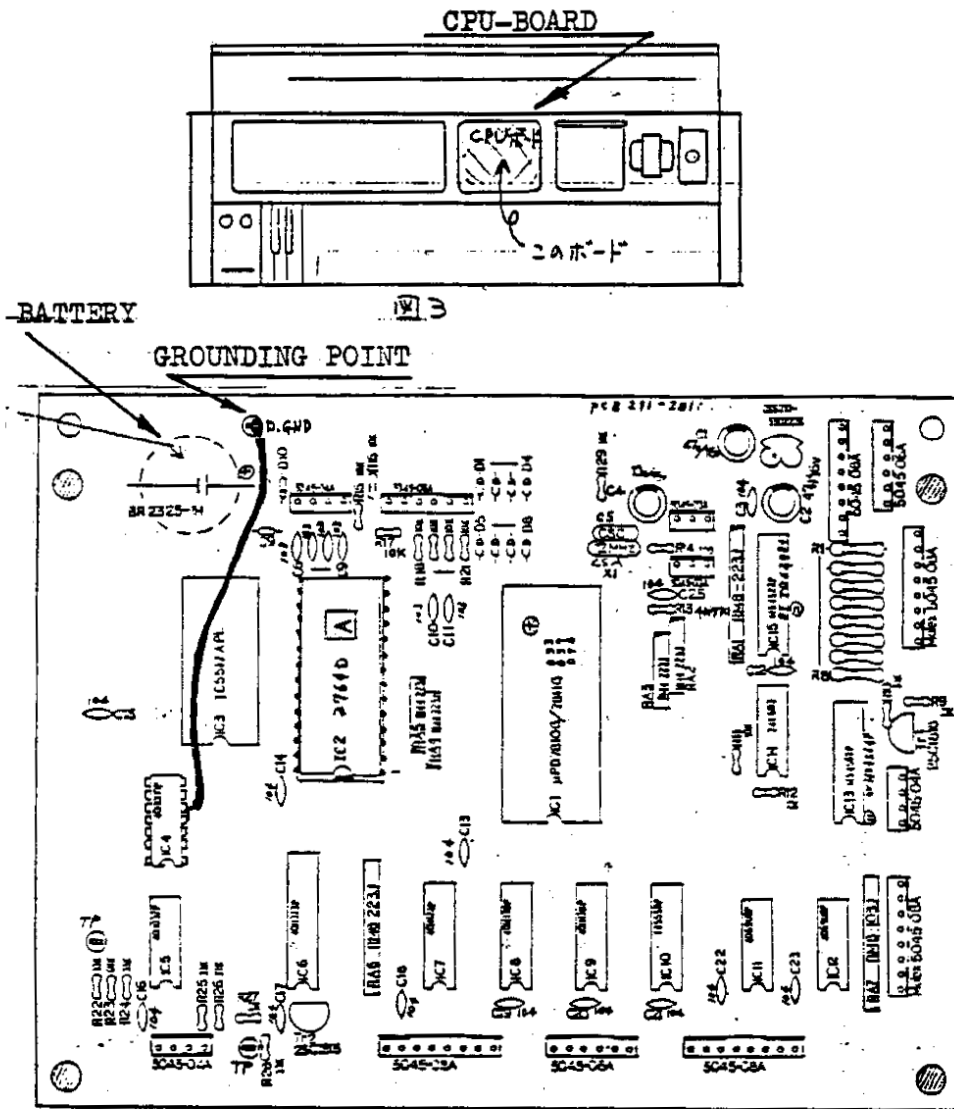
It was found that JUNO-106 is likely to break memory data in a short period as IC-4 40H000P on CPU BOARD draws a variance current ranging 250 micro ampere to zero.

The "floating" inputs (pins 4 and 5) of the unused section of IC-4 40H000P are the cause of this problem. The solution is that they should be connected to ground point by using a jumper wire. Please refer to the attached drawing.

Pins 4 and 5 must be connected to grounding point by using a jumper wire.

- STEP-1: Check whether the battery voltage is more than 2.8V or not.
- STEP-2: If the battery voltage is less than 2.8V, please replace the battery with new one and then take above modification to CPU BOARD.
- STEP-3: If the battery voltage is more than 2.8V, you do not need to replace the battery but need to take the modification.

NOTE: Firstly, connect a jumper wire to above ground point to prevent breaking IC from happening on, and then, connect the jumper wire to pins 4 and 5 of IC-4.
