Roland SERVICE INFORMATION

NO.	100202
DATE	July 29, 1983

PRODUCT AFFECTED: JUNO-60/6

A Failure of IC 3R01

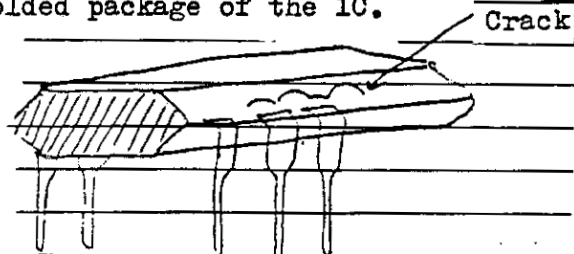
From our repair record in Japan market, it was found that some IC 3R01 in JUNO-60/6 became in failure and it was caused by a crack which happened on the molded package of the IC.

It seems that there is a possibility for IC 3R01 to be mixed in JUNO-60/6 with above serial numbers. We wish you to pay your attention to IC 3R01 when you have a chance to repair them. We advise you to replace the IC with a crack with new one which is sent under separate air service, even though the IC works normally, if you would find it.
